High Voltage Sparking in a Decommissioned CESR Horizontal Separator

James J. Welch

Laboratory of Nuclear Studies, Cornell University, February 16, 1995

A horizontal separator in CESR at 44W was removed and replaced with a new low impedance model in June 1994. The removed device had had the highest spark rate of the four installed separators. In August 1994 it was decommissioned, cut up and inspected. Some interesting observations were made and are reported in this paper.

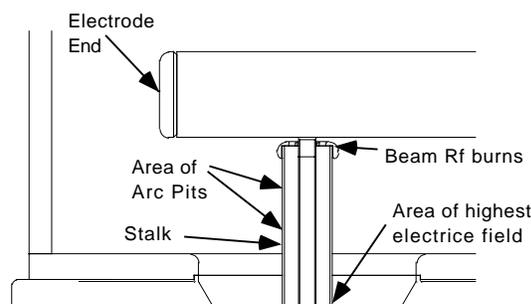
As expected a substantial number of arcing scars were found on the ends of the high voltage electrodes. This area was known to be a source of intense x-ray radiation during high voltage processing. Also, the ends of the electrodes were quite close to the (grounded) chamber wall and had rather sharp radii resulting in peak electric field levels that were many times higher than the electric field between the electrodes. See figure 1 and figure 2.

Figure 1: Major parts of the separator high voltage electrode supports where sparking was taking place.

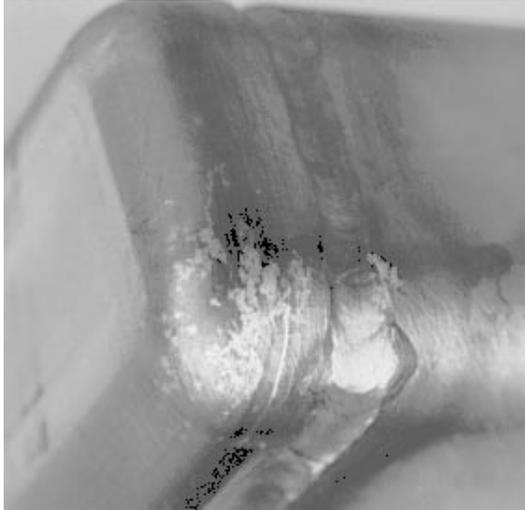
Figure 2: Arcing marks at one of the ends of one of the high voltage electrode shown in this photo. They are particularly prevalent on the sharply rounded corner where the electric field is the highest.

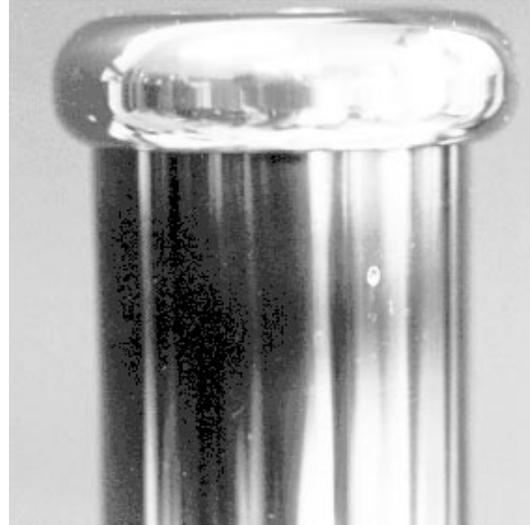
Figure 3: Discoloration typical of three out of four of the the high voltage stalks and corona rings taken from the 45W horizontal separator.

three had substantial discoloration, high voltage arc pitting, and melted stainless steel at rf contact points, while one showed neither discoloration nor arc pitting, and only a relatively small spot of melted stainless at a possible rf contact point. If the discoloration and melted stainless are indeed due to beam rf arcing, then the observed high voltage arcing pits would seem to be associated with it, though the association could be merely coincidental.

The discoloration of the three damaged stalks was a patina of blue to brown around the upper 1 to 1.5 inches (see figure 3). The same patina appeared on the corona rings which rest on top of the stalks. A darker patina appeared on the main part of the electrode near the top of the stalks as shown in figure 5. The numerous arc pits were about 2 inches from the top and distributed more or less uniformly azimuthally around the stalks. Melted

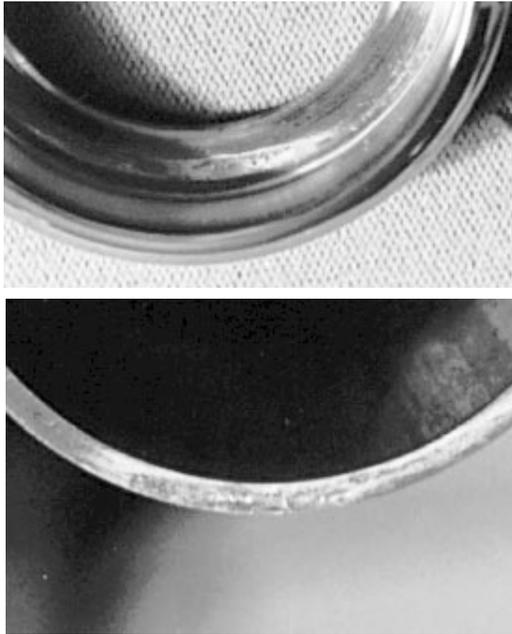
stainless steel was seen on the underside of the corona ring, where it makes physical and rf contact with the stalk (where there could not have been any DC electric field), and seen on the corresponding spot on the end of the stalk. See figure 4. It is then difficult to imagine any mechanism that could melt the stainless steel other than beam rf arcing.

These observations support the hypothesis that beam rf arcing caused melting of the stalk and corona ring and led to a substantial amount of material being deposited onto nearby surfaces. Presumably the debris from the arcing either initiated a DC breakdown directly, or continually contaminated the surfaces and reduced the DC breakdown potential. This hypothesis is supported by the circumstantial fact that the arc pits on the stalk are not in the region of the stalk where electric field is the highest, which is about three inches below the pitted region.

Figure 4: Beam rf arcing damage at the junction between the stalk (lower picture) and the underside of the corona ring (upper picture).

New low impedance separators are being installed to replace the older units. The corresponding joint between the corona ring and the stalk is a tightly threaded assembly of two stainless parts and can probably take substantially more beam rf power. Also, even though the stored beam current will be raised by a factor of three as part of the luminosity upgrade, the maximum level of beam rf currents should not be much different. The lower impedance of the new separators largely offsets the higher beam currents we expect to reach in the near future.

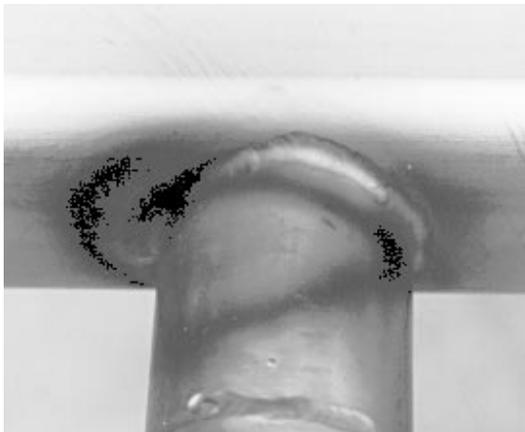
Figure 5: Discoloration on main part of the electrode near apparent arcing locations.
