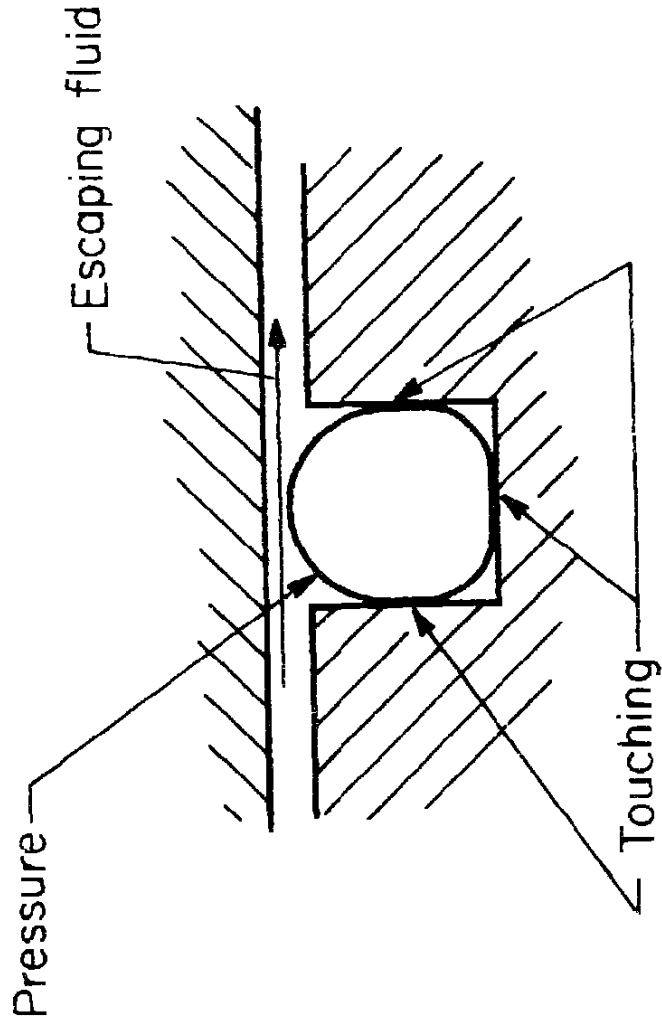
Figure 1.2 Leakage past a narrow O-ring groove.
