Microscopic examination of defects located by thermometry in 1.5 GHz superconducting niobium cavities*

J. Knobloch, R. Durand, H. Muller and H. Padamsee
F.R. Newman Laboratory of Nuclear Studies, Cornell University, Ithaca NY 14853

Abstract

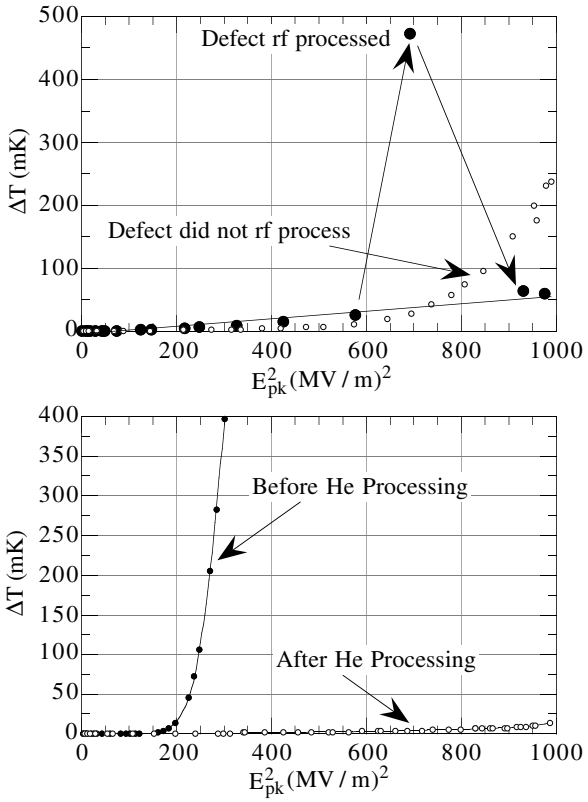
Figures 1a & 1b: FE heating measured for sites which a) didn't process (shown in fig. 2b), b) processed in the rf field (shown in fig. 2c) and c) He processed (shown in fig. 2d). The heating is plotted vs. the electric field squared so that background heating in the absence of FE is linear.

During the tests the cavity fields were increased while measuring the cavity Q and temperature distributions at regular intervals. In one case an emitter *rf processed* [6], that is, upon raising the field beyond a threshold, the emitter's heating was permanently extinguished. (see fig. 1a).

In another case, the maximum power dissipated in the cavity was 8 W, most of which was absorbed by a single emitter. Subsequently *He processing* [7] was successfully performed on the cavity resulting in the elimination of the emitter (fig. 1b).

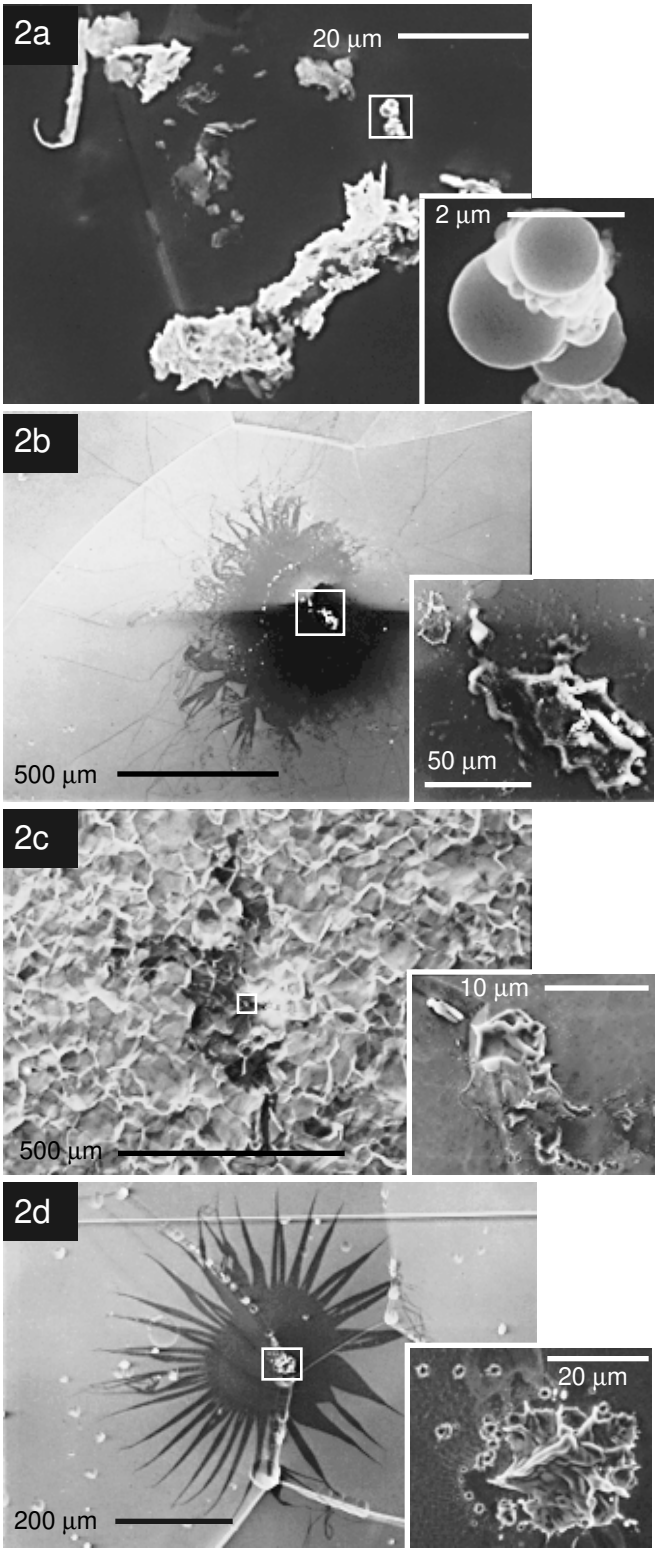
A) Three unprocessed FE sites (entries 1-3) consisted of foreign particles a few 10's of μm in size which had been partially melted. Fig. 2a shows an example of such a defect. Note the molten region which is magnified in the inset.

B) In two unprocessed cases (entries 4 & 5) we found regions of limited cratering surrounded by a large area (diameter = 500 μm) of reduced secondary electron emission coefficient. This feature has been observed in the past [3],[8] and is known as a starburst because of its dark star shaped appearance in the SEM. In the case of entry 5, we also found a large (70 μm) foreign particle which had melted to a large extent (see fig. 2b)

C) At the location of the rf processed emitter (entry 6) we found an irregularly shaped starburst surrounding a region of significant cratering and melting (see fig. 2c) Some remnants of a foreign particle (carbon) existed as well.

D) The helium processed emitter (entry 7) had a very regularly shaped starburst (see fig. 2d). No foreign elements were detected at the center which consisted entirely of severely molten Nb surrounded by some cratering.

2. As the electric field is increased, the FE current density rises locally to values sufficient to melt parts of the site (fig. 2a). FE may perhaps occur at several points on the defect simultaneously, so that the melting process doesn't noticeably affect the defect's collective FE characteristics.

3. Further field increases result in extreme heating (ultimately leading to a local explosive event). A plasma builds up, which is fueled by desorption/evaporation of one or more of the local emitters. Through a cleaning action of the plasma, a starburst is produced [8] (fig. 2b). Neighboring emitters may still be in the first two stages, so that again the overall FE characteristics of the defect are only little changed.

4. Finally, the plasma itself results in significant heating over a region encompassing a large portion of the defect. Once a critical temperature is exceeded the entire defect processes (fig. 2c). The emitter in fig. 2b was perhaps just before this stage. Of particular note is the fact that almost the entire defect seems to have melted.

Figures 2a - 2d: Examples of FE defects found for the four cases A - D discussed in the text. It is speculated that these figures represent a natural progression in FE, ultimately leading to the processing of a defect. The insets are magnifications of the areas in the rectangles.

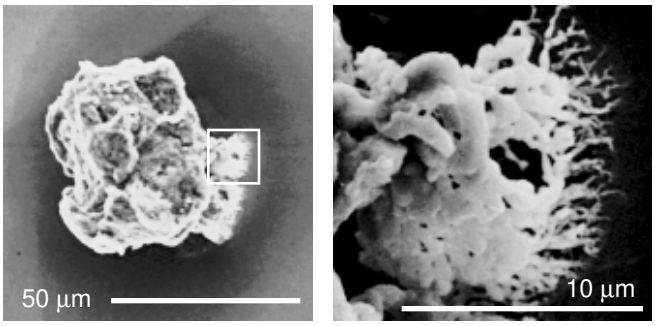
1. We found a thermal defect (fig. 3), which at higher field levels could have lead to thermal breakdown. The copper particle at that location could not be removed by high pressure solid CO_2 cleaning. Parts of it seem to have melted, which may explain why the particle was so firmly attached. Calculations [9] indicate that melting was possible at the fields attained, provided the particle was thermally isolated.

Figures 3a & 3b: A thermal defect (copper)
